**Horse Barn Demolition**

# **PRE-DEMOLITION HAZARDOUS MATERIALS SURVEY REPORT**

## **BSD-Future Elementary School**

**Former Forward Stride Horse Facility  
SW Horse Tail Lane, Beaverton, OR 97007  
Tax Lot ID #1S1310002200**

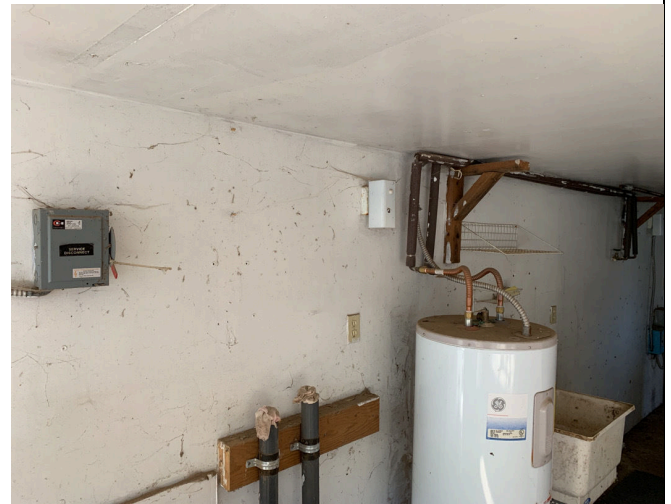
**Sample Numbers:** HB-01A, HB-01B, HB-01C  
**Material Description:** Wallboard Gypsum with Joint Compound  
**Material Color:** White  
**Accessible Material:** Accessible  
**Reason Inaccessible:** N/A  
**Asbestos Detected:** Negative  
**Asbestos Type:** No Asbestos Detected  
**Homogeneous Area:** House  
**Total Approximate Quantity:** 2000 SF  
**Condition:** Good  
**Material Type:** Misc.  
**NESHAP Category:** N/A  
**Notes:** Not Applicable

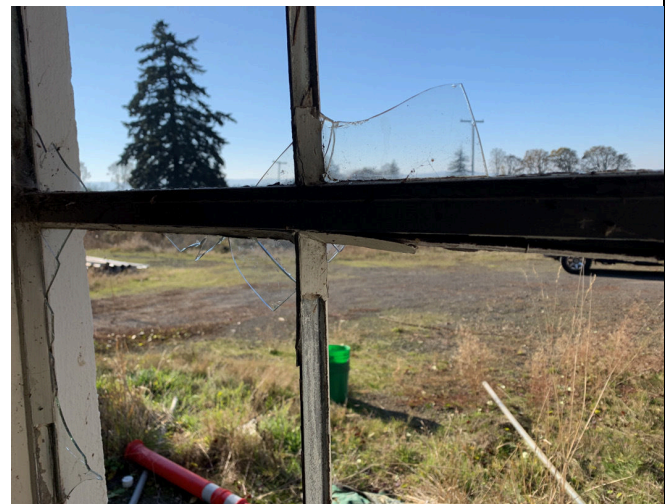
<b>Asbestos Positive Materials</b> <b>BSD-Future Elementary School</b> <b>Former Forward Stride Horse Facility</b>					
Samples	Material	Location	Percentage / Type	Approx. Quantity	Condition / Material Type / NESHAP Category
HB-02A HB-02B HB-02C	White Window Glazing	Windowsills	3% Chrysotile	60 LF	Significantly Damaged Misc.

Results of laboratory analysis confirmed asbestos was identified within some of the bulk samples collected. The asbestos-containing materials were found to be in significantly damaged condition at the time of the inspection. Removal of asbestos-containing materials should be performed by a State of Oregon Department of Environmental Quality licensed asbestos abatement contractor, and should be handled, stored, and disposed of according to all local, state, and federal regulations.

**Sample Numbers:** HB-02A, HB-02B, HB-02C  
**Material Description:** Window Glazing  
**Material Color:** White  
**Accessible Material:** Accessible  
**Reason Inaccessible:** N/A  
**Asbestos Detected:** Positive  
**Asbestos Type:** 3% Chrysotile  
**Homogeneous Area:** Windowsills  
**Total Approximate Quantity:** 60 LF  
**Condition:** Significantly Damaged  
**Material Type:** Misc.  
**NESHAP Category:** Cat. II  
**Notes:** Not Applicable

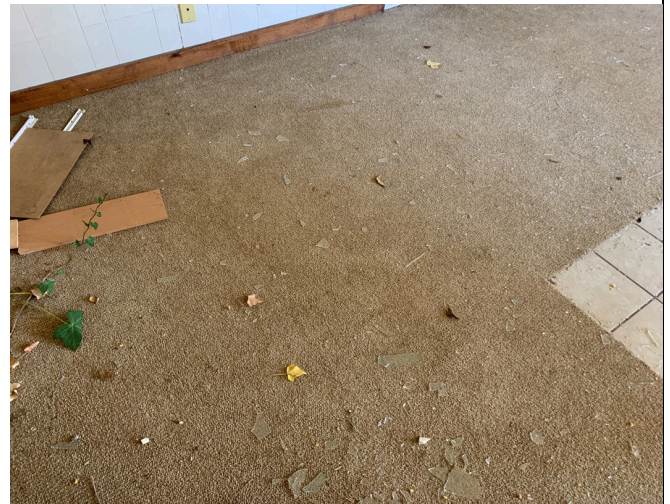
**Sample Numbers:** HB-03A, HB-03B, HB-03C  
**Material Description:** Carpet Glue  
**Material Color:** Yellow  
**Accessible Material:** Accessible  
**Reason Inaccessible:** N/A  
**Asbestos Detected:** Negative  
**Asbestos Type:** No Asbestos Detected  
**Homogeneous Area:** 1st Floor  
**Total Approximate Quantity:** 800 SF  
**Condition:** Good  
**Material Type:** Misc.  
**NESHAP Category:** N/A  
**Notes:** Not Applicable

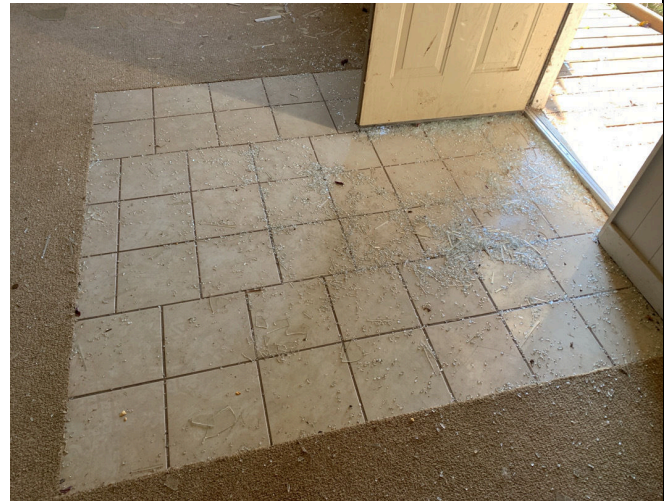
**Sample Numbers:** HB-04A, HB-04B, HB-04C  
**Material Description:** Ceramic Tile Grout/Glue  
**Material Color:** Grey  
**Accessible Material:** Accessible  
**Reason Inaccessible:** N/A  
**Asbestos Detected:** Negative  
**Asbestos Type:** No Asbestos Detected  
**Homogeneous Area:** Front House Entry  
**Total Approximate Quantity:** 30 SF  
**Condition:** Good  
**Material Type:** Misc.  
**NESHAP Category:** N/A  
**Notes:** Not Applicable

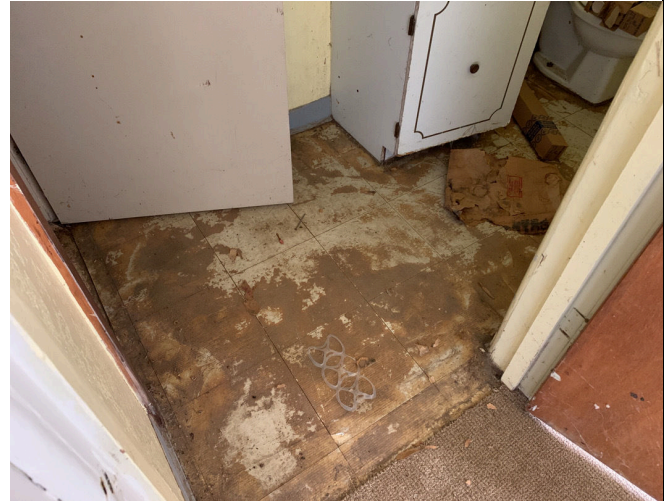
**Sample Numbers:** HB-05A, HB-05B, HB-05C  
**Material Description:** 12" x 12" Floor Tile & Associated Glue  
**Material Color:** Off-White  
**Accessible Material:** Accessible  
**Reason Inaccessible:** N/A  
**Asbestos Detected:** Negative  
**Asbestos Type:** No Asbestos Detected  
**Homogeneous Area:** 1st Floor Bathroom  
**Total Approximate Quantity:** 32 SF  
**Condition:** Good  
**Material Type:** Misc.  
**NESHAP Category:** N/A  
**Notes:** Not Applicable

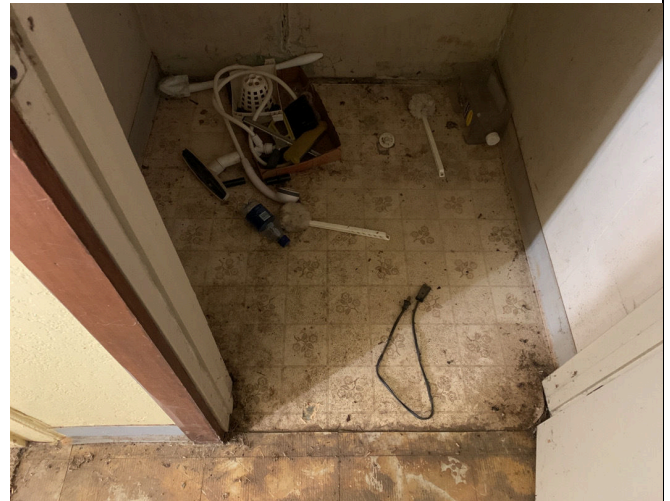
**Sample Numbers:** HB-06A, HB-06B, HB-06C  
**Material Description:** Sheet Vinyl Flooring & Associated Glue  
**Material Color:** Beige  
**Accessible Material:** Accessible  
**Reason Inaccessible:** N/A  
**Asbestos Detected:** Negative  
**Asbestos Type:** No Asbestos Detected  
**Homogeneous Area:** 1st Floor Closet, 1st Floor Bathroom (Under Floor Tile)  
**Total Approximate Quantity:** 48 SF  
**Condition:** Good  
**Material Type:** Misc.  
**NESHAP Category:** N/A  
**Notes:** Not Applicable

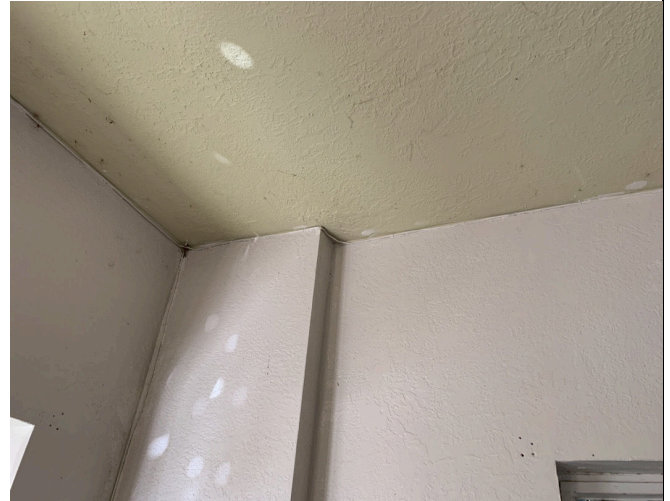
**Sample Numbers:** HB-07A, HB-07B, HB-07C  
**Material Description:** Acoustic Wall & Ceiling Finish  
**Material Color:** White  
**Accessible Material:** Accessible  
**Reason Inaccessible:** N/A  
**Asbestos Detected:** Negative  
**Asbestos Type:** No Asbestos Detected  
**Homogeneous Area:** Living Room  
**Total Approximate Quantity:** 1000 SF  
**Condition:** Good  
**Material Type:** Surfacing  
**NESHAP Category:** N/A  
**Notes:** Not Applicable

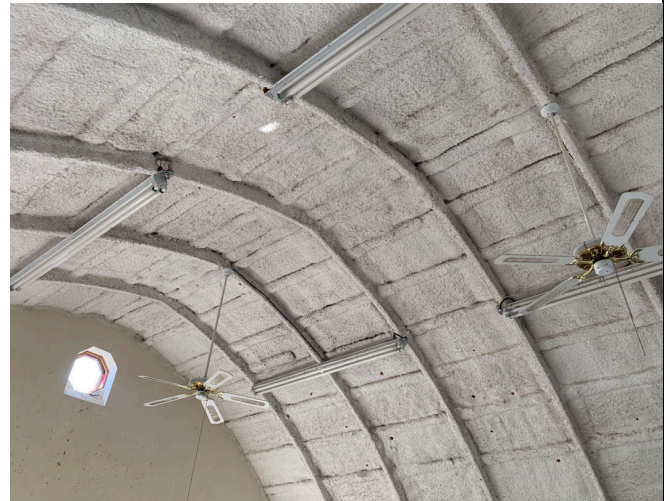
**Sample Numbers:** HB-08A, HB-08B, HB-08C  
**Material Description:** Spray-on Insulation & Foam  
**Material Color:** White  
**Accessible Material:** Accessible  
**Reason Inaccessible:** N/A  
**Asbestos Detected:** Negative  
**Asbestos Type:** No Asbestos Detected  
**Homogeneous Area:** 2nd Floor of House  
**Total Approximate Quantity:** 1000 SF  
**Condition:** Good  
**Material Type:** Surfacing  
**NESHAP Category:** N/A  
**Notes:** Not Applicable

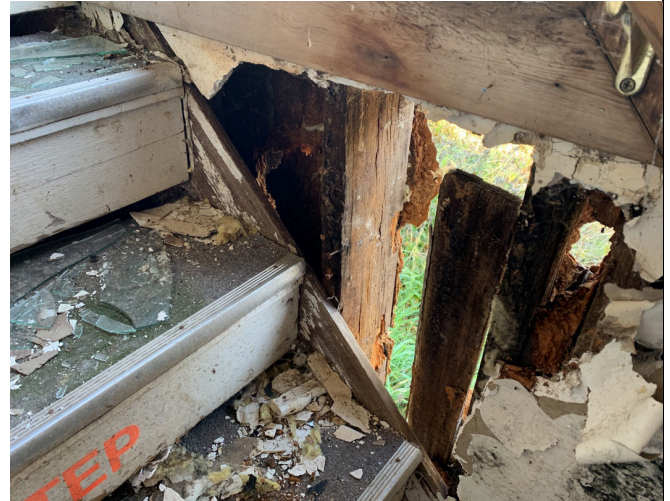
**Sample Numbers:** HB-09A, HB-09B, HB-9C  
**Material Description:** Wall Underlayment  
**Material Color:** Black  
**Accessible Material:** Accessible  
**Reason Inaccessible:** N/A  
**Asbestos Detected:** Negative  
**Asbestos Type:** No Asbestos Detected  
**Homogeneous Area:** House Exterior Walls  
**Total Approximate Quantity:** 420 SF  
**Condition:** Significantly Damaged  
**Material Type:** Misc.  
**NESHAP Category:** N/A  
**Notes:** Not Applicable

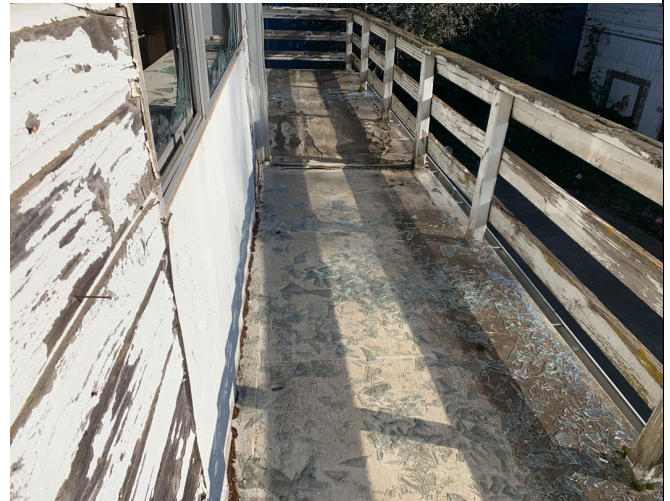
**Sample Numbers:** HB-10A, HB-10B, HB-10C  
**Material Description:** Membrane Cover  
**Material Color:** Black  
**Accessible Material:** Accessible  
**Reason Inaccessible:** N/A  
**Asbestos Detected:** Negative  
**Asbestos Type:** No Asbestos Detected  
**Homogeneous Area:** Balconies  
**Total Approximate Quantity:** 900 SF  
**Condition:** Significantly Damaged  
**Material Type:** Misc.  
**NESHAP Category:** N/A  
**Notes:** Not Applicable

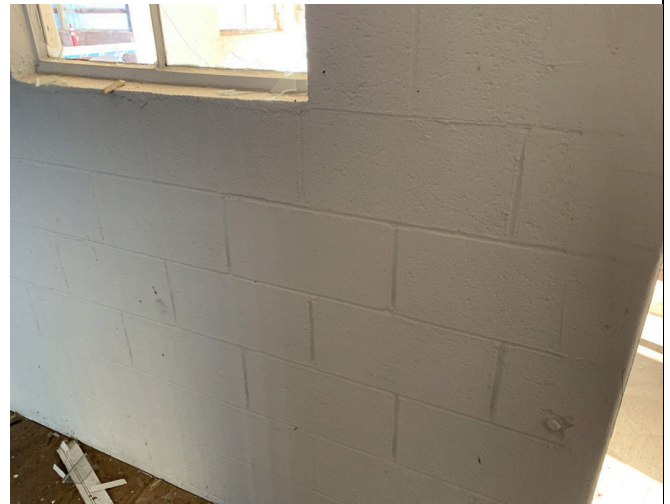
**Sample Numbers:** HB-11A, HB-11B, HB-11C  
**Material Description:** CMU Grout  
**Material Color:** Grey  
**Accessible Material:** Accessible  
**Reason Inaccessible:** N/A  
**Asbestos Detected:** Negative  
**Asbestos Type:** No Asbestos Detected  
**Homogeneous Area:** House Interior  
**Total Approximate Quantity:** 200 SF  
**Condition:** Good  
**Material Type:** Misc.  
**NESHAP Category:** N/A  
**Notes:** Not Applicable

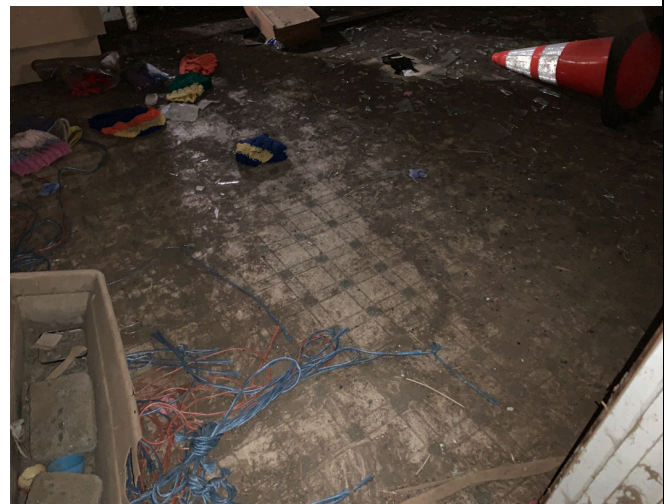
**Sample Numbers:** HB-12A, HB-12B, HB-12C  
**Material Description:** Sheet Vinyl Flooring & Associated Glue  
**Material Color:** Green White  
**Accessible Material:** Accessible  
**Reason Inaccessible:** N/A  
**Asbestos Detected:** Negative  
**Asbestos Type:** No Asbestos Detected  
**Homogeneous Area:** Blue Barn Office  
**Total Approximate Quantity:** 400 SF  
**Condition:** Significantly Damaged  
**Material Type:** Misc.  
**NESHAP Category:** N/A  
**Notes:** Not Applicable

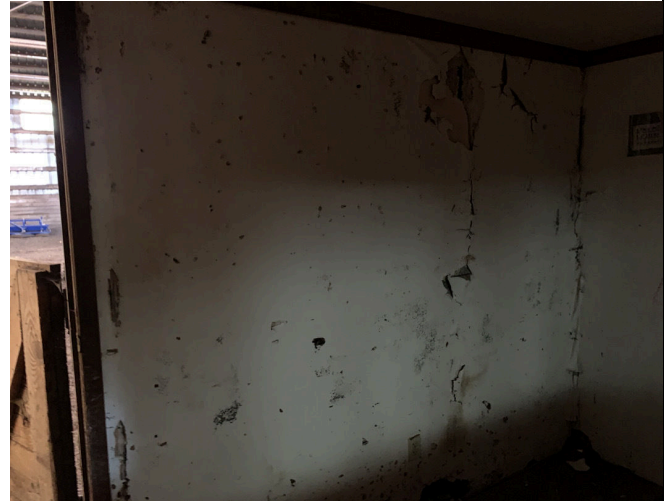
**Sample Numbers:** HB-13A, HB-13B, HB-13C  
**Material Description:** Wallboard Gypsum with Joint Compound  
**Material Color:** White  
**Accessible Material:** Accessible  
**Reason Inaccessible:** N/A  
**Asbestos Detected:** Negative  
**Asbestos Type:** No Asbestos Detected  
**Homogeneous Area:** Blue Barn Office  
**Total Approximate Quantity:** 500 SF  
**Condition:** Significantly Damaged  
**Material Type:** Misc.  
**NESHAP Category:** N/A  
**Notes:** Not Applicable

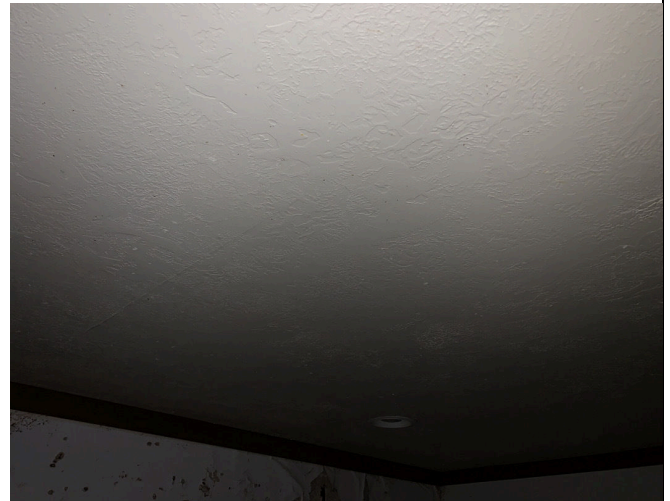
**Sample Numbers:** HB-14A, HB-14B, HB-14C  
**Material Description:** Acoustic Ceiling Finish  
**Material Color:** White  
**Accessible Material:** Accessible  
**Reason Inaccessible:** N/A  
**Asbestos Detected:** Negative  
**Asbestos Type:** No Asbestos Detected  
**Homogeneous Area:** Blue Barn Office  
**Total Approximate Quantity:** 400 SF  
**Condition:** Good  
**Material Type:** Surfacing  
**NESHAP Category:** N/A  
**Notes:** Not Applicable

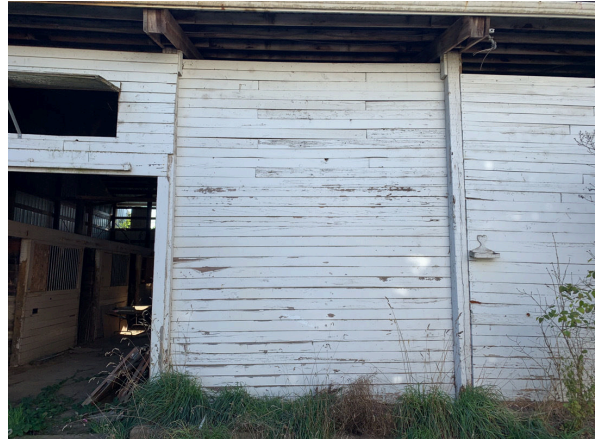
**Sample Numbers:** HB-L-01  
**Sample Location:** White Barn  
**Description:** Exterior White  
**Laboratory Result (%):** <0.0077  
**Substrate:** Wood  
**Paint Locations:** Exterior Siding

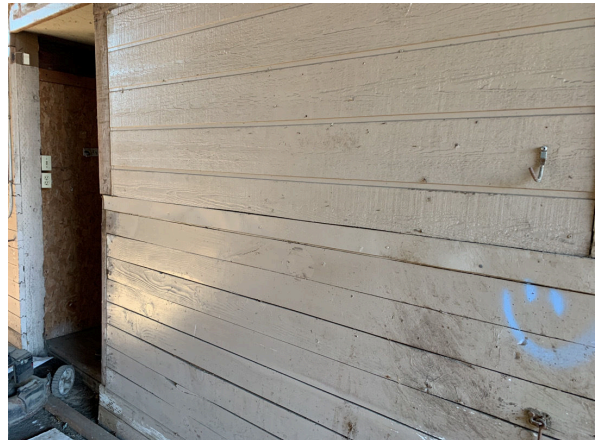
**Sample Numbers:** HB-L-02  
**Sample Location:** White Barn  
**Description:** Interior Beige  
**Laboratory Result (%):** <0.0077  
**Substrate:** Wood  
**Paint Locations:** Horse Stalls

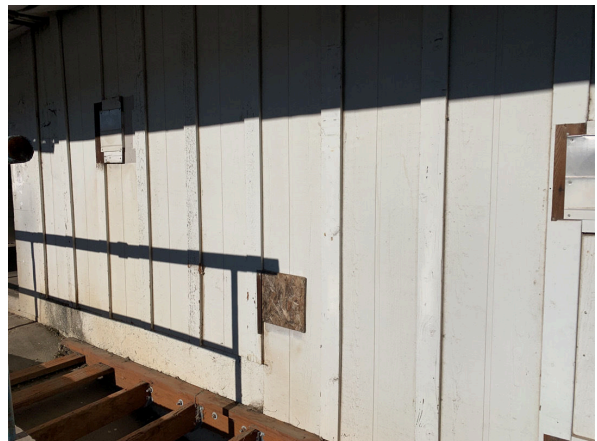
**Sample Numbers:** HB-L-03  
**Sample Location:** House  
**Description:** Exterior White  
**Laboratory Result (%):** <0.0082  
**Substrate:** Wood  
**Paint Locations:** Exterior Siding

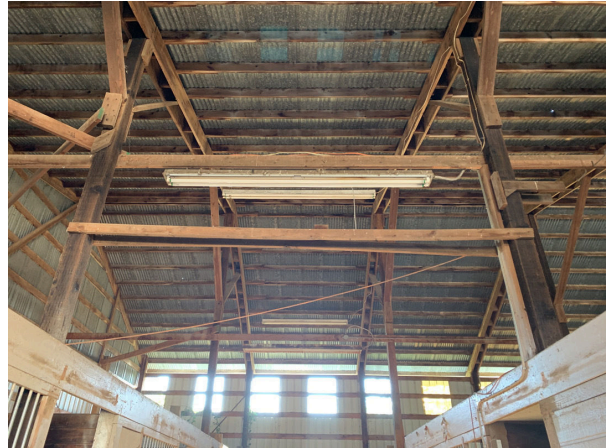
**Area:** White Barn  
**Description:** Heavy Metal Containing Devices Fluorescent (Green Tip)  
**Quantity:** 18  
**Notes:** N/A

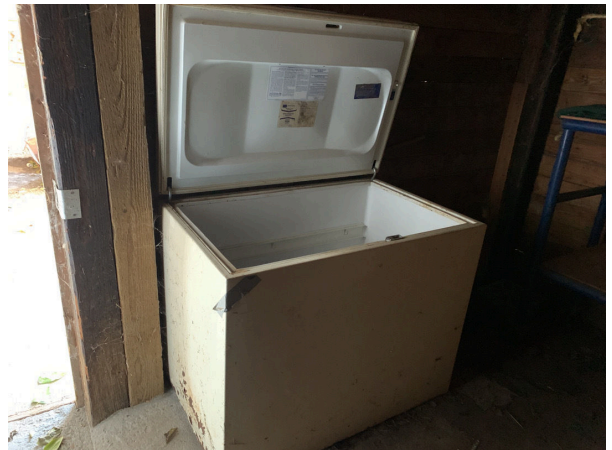
**Area:** White Barn  
**Description:** Refrigerants Retail Floor Cooler  
**Quantity:** 1  
**Notes:** N/A

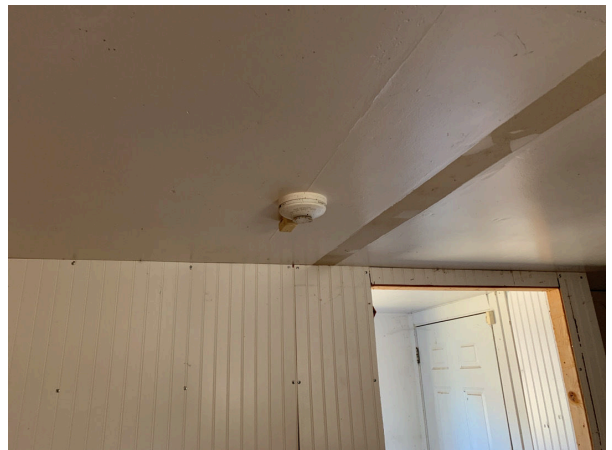
**Area:** House  
**Description:** Heavy Metal Containing Devices Smoke Detector Batteries  
**Quantity:** 1  
**Notes:** N/A

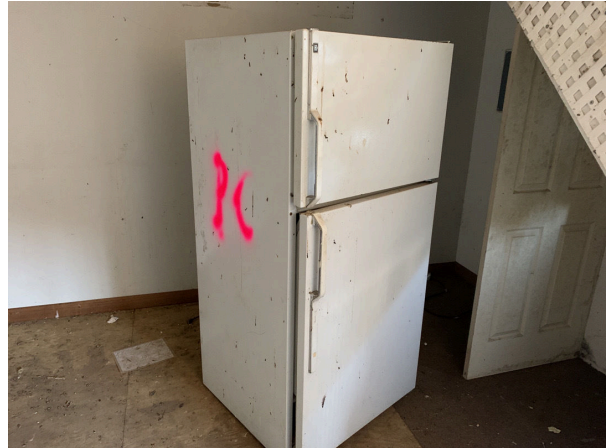
**Area:** House  
**Description:** Refrigerants Refrigerator  
**Quantity:** 1  
**Notes:** N/A

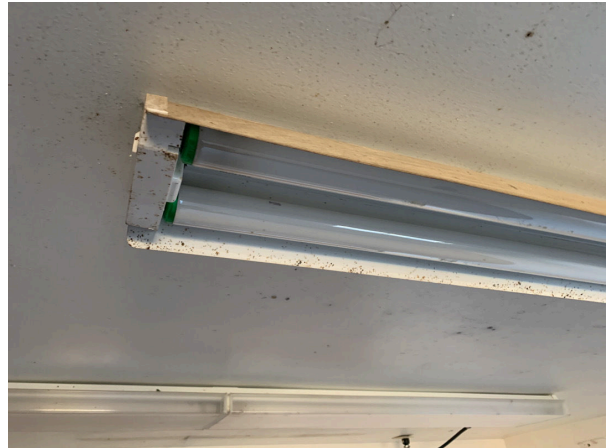
**Area:** House  
**Description:** Heavy Metal Containing Devices Fluorescent  
(Green Tip)  
**Quantity:** 26  
**Notes:** N/A

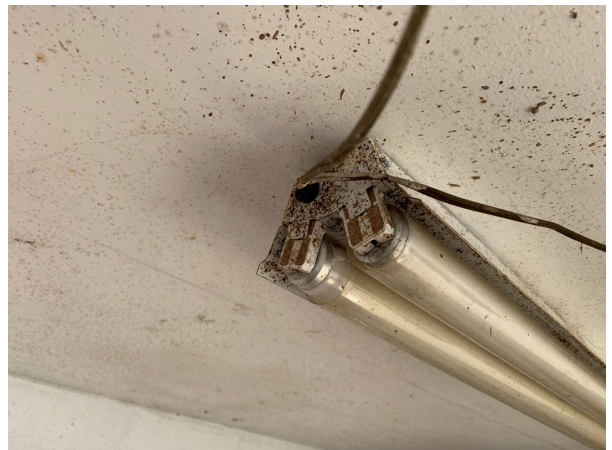
**Area:** House  
**Description:** Heavy Metal Containing Devices Fluorescent  
(Silver Tip)  
**Quantity:** 12  
**Notes:** N/A

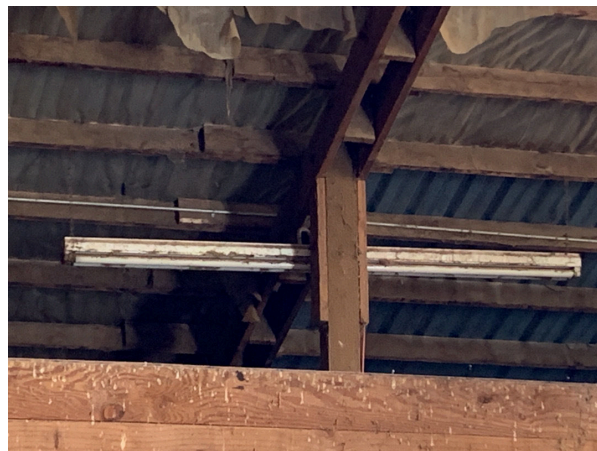
**Area:** Blue Barn

**Description:** Heavy Metal Containing Devices Fluorescent  
(Green Tip)

**Quantity:** 100
