# **ROOF MOISTURE STUDY**

**FIVE OAKS MIDDLE SCHOOL**

**Project Number: 21042**

*June 26, 2021*

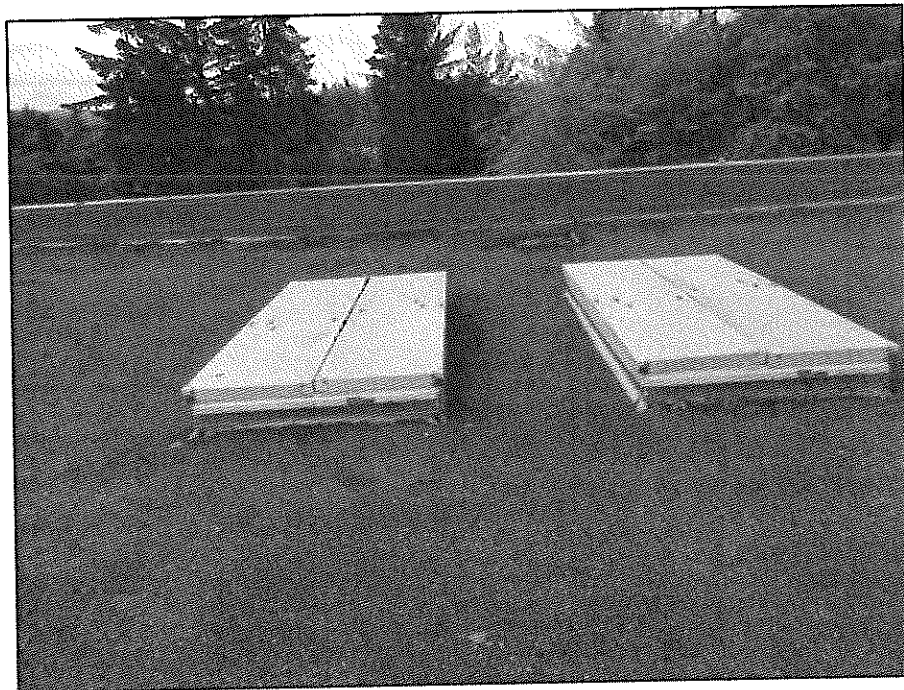
**Sec. 1.74 – Roof F: View of smoke hatches in southeast section of roof.**

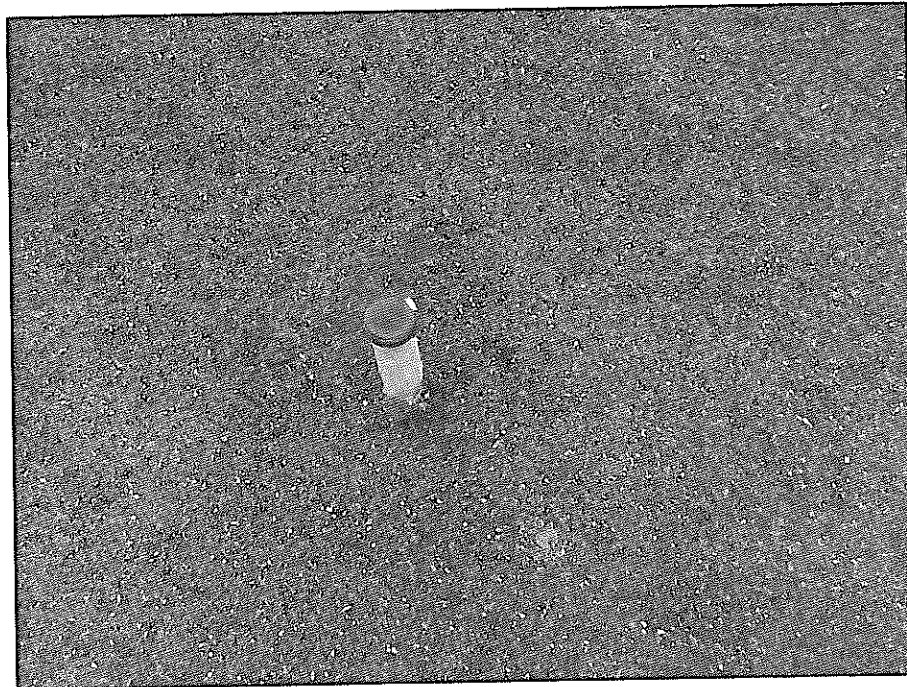
**Sec. 1.110 – View of capped plumbing vent.**
