SOLICITATION ADDENDUM NO. 2
ITB 22-0022
Horse Barn Demolition

**PRE-DEMOLITION HAZARDOUS
MATERIALS SURVEY REPORT**

BSD-Future Elementary School

Former Forward Stride Horse Facility
SW Horse Tail Lane, Beaverton, OR 97007
Tax Lot ID #1S1310002200

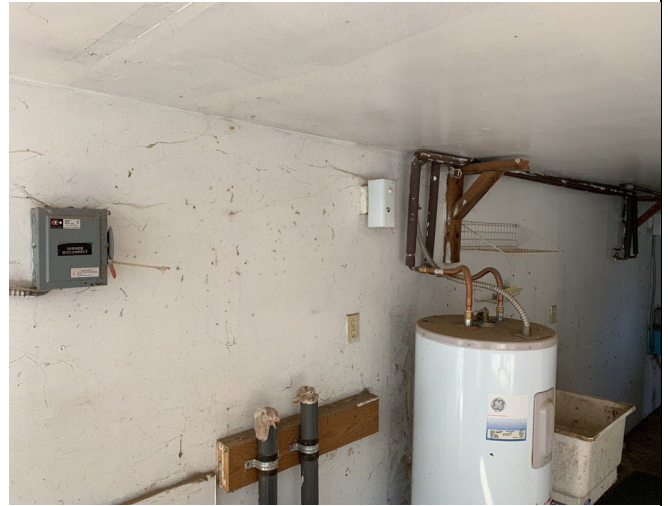
Sample Numbers: HB-01A, HB-01B, HB-01C
Material Description: Wallboard Gypsum with Joint Compound
Material Color: White
Accessible Material: Accessible
Reason Inaccessible: N/A
Asbestos Detected: Negative
Asbestos Type: No Asbestos Detected
Homogeneous Area: House
Total Approximate Quantity: 2000 SF
Condition: Good
Material Type: Misc.
NESHAP Category: N/A
Notes: Not Applicable

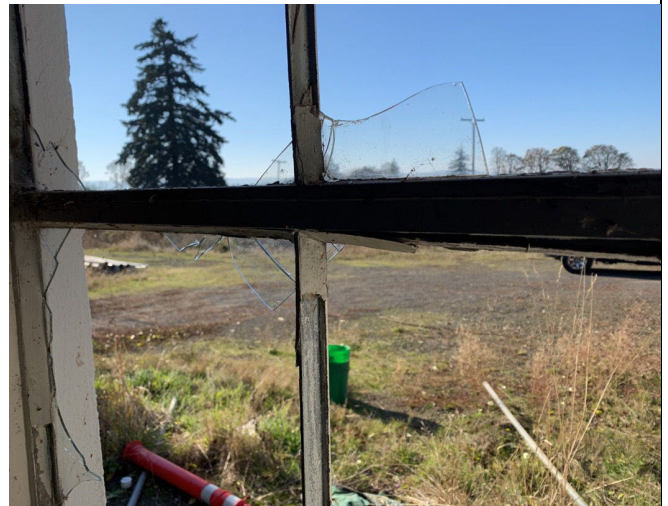
Asbestos Positive Materials BSD-Future Elementary School Former Forward Stride Horse Facility					
Samples	Material	Location	Percentage / Type	Approx. Quantity	Condition / Material Type / NESHAP Category
HB-02A HB-02B HB-02C	White Window Glazing	Windowsills	3% Chrysotile	60 LF	Significantly Damaged Misc.

Sample Numbers: HB-02A, HB-02B, HB-02C
Material Description: Window Glazing
Material Color: White
Accessible Material: Accessible
Reason Inaccessible: N/A
Asbestos Detected: Positive
Asbestos Type: 3% Chrysotile
Homogeneous Area: Windowsills
Total Approximate Quantity: 60 LF
Condition: Significantly Damaged
Material Type: Misc.
NESHAP Category: Cat. II
Notes: Not Applicable

ANSWER: Per attached "Hazardous Materials Survey" the 60LF of hazardous materials/window glazing must be removed by substantial completion date.

Results of laboratory analysis confirmed asbestos was identified within some of the bulk samples collected. The asbestos-containing materials were found to be in significantly damaged condition at the time of the inspection. Removal of asbestos-containing materials should be performed by a State of Oregon Department of Environmental Quality licensed asbestos abatement contractor, and should be handled, stored, and disposed of according to all local, state, and federal regulations.

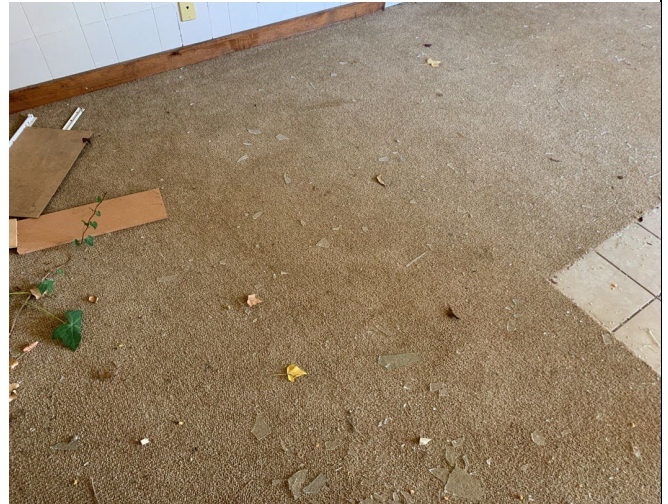
Sample Numbers: HB-03A, HB-03B, HB-03C
Material Description: Carpet Glue
Material Color: Yellow
Accessible Material: Accessible
Reason Inaccessible: N/A
Asbestos Detected: Negative
Asbestos Type: No Asbestos Detected
Homogeneous Area: 1st Floor
Total Approximate Quantity: 800 SF
Condition: Good
Material Type: Misc.
NESHAP Category: N/A
Notes: Not Applicable

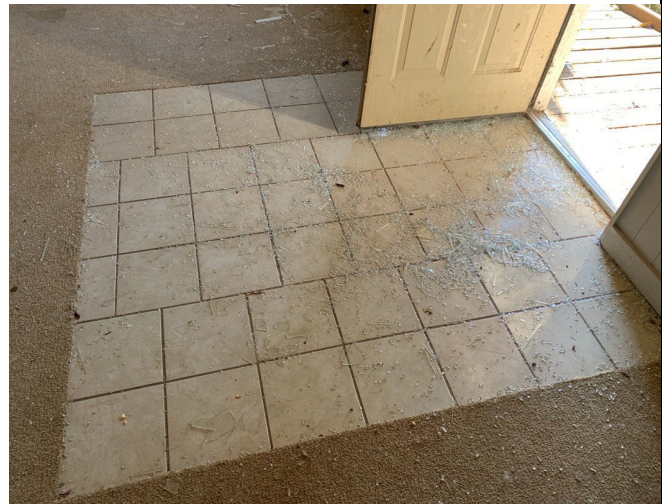
Sample Numbers: HB-04A, HB-04B, HB-04C
Material Description: Ceramic Tile Grout/Glue
Material Color: Grey
Accessible Material: Accessible
Reason Inaccessible: N/A
Asbestos Detected: Negative
Asbestos Type: No Asbestos Detected
Homogeneous Area: Front House Entry
Total Approximate Quantity: 30 SF
Condition: Good
Material Type: Misc.
NESHAP Category: N/A
Notes: Not Applicable

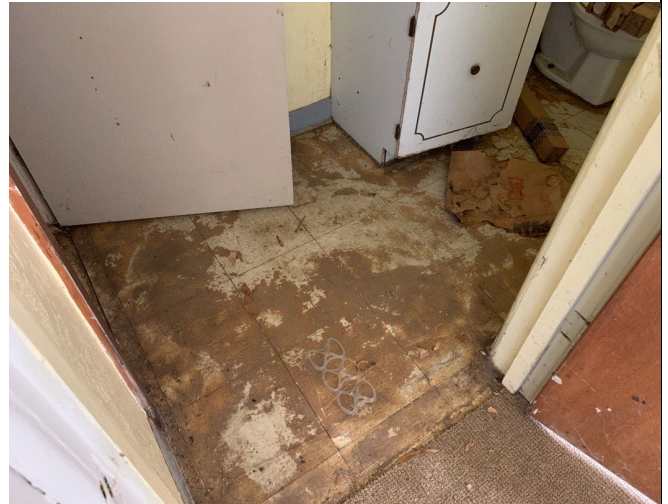
Sample Numbers: HB-05A, HB-05B, HB-05C
Material Description: 12" x 12" Floor Tile & Associated Glue
Material Color: Off-White
Accessible Material: Accessible
Reason Inaccessible: N/A
Asbestos Detected: Negative
Asbestos Type: No Asbestos Detected
Homogeneous Area: 1st Floor Bathroom
Total Approximate Quantity: 32 SF
Condition: Good
Material Type: Misc.
NESHAP Category: N/A
Notes: Not Applicable

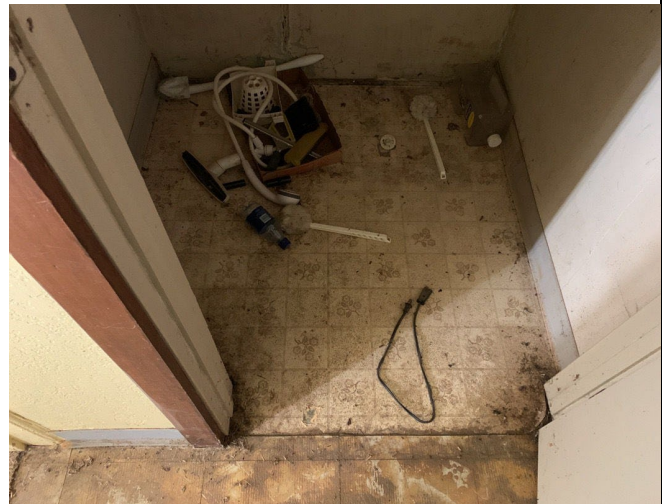
Sample Numbers: HB-06A, HB-06B, HB-06C
Material Description: Sheet Vinyl Flooring & Associated Glue
Material Color: Beige
Accessible Material: Accessible
Reason Inaccessible: N/A
Asbestos Detected: Negative
Asbestos Type: No Asbestos Detected
Homogeneous Area: 1st Floor Closet, 1st Floor Bathroom (Under Floor Tile)
Total Approximate Quantity: 48 SF
Condition: Good
Material Type: Misc.
NESHAP Category: N/A
Notes: Not Applicable

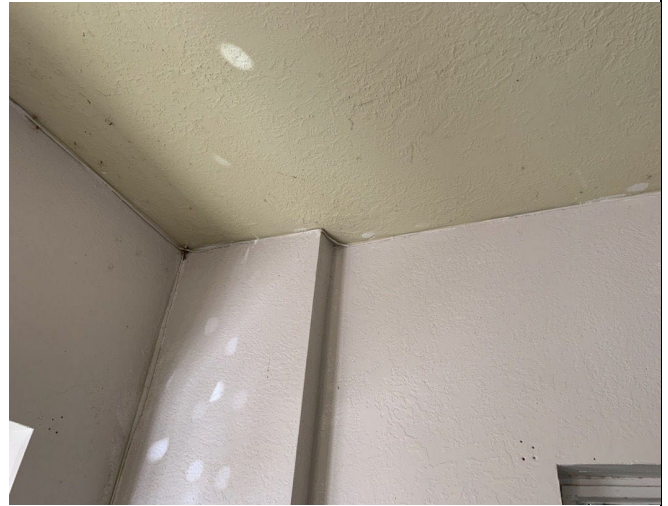
Sample Numbers: HB-07A, HB-07B, HB-07C
Material Description: Acoustic Wall & Ceiling Finish
Material Color: White
Accessible Material: Accessible
Reason Inaccessible: N/A
Asbestos Detected: Negative
Asbestos Type: No Asbestos Detected
Homogeneous Area: Living Room
Total Approximate Quantity: 1000 SF
Condition: Good
Material Type: Surfacing
NESHAP Category: N/A
Notes: Not Applicable

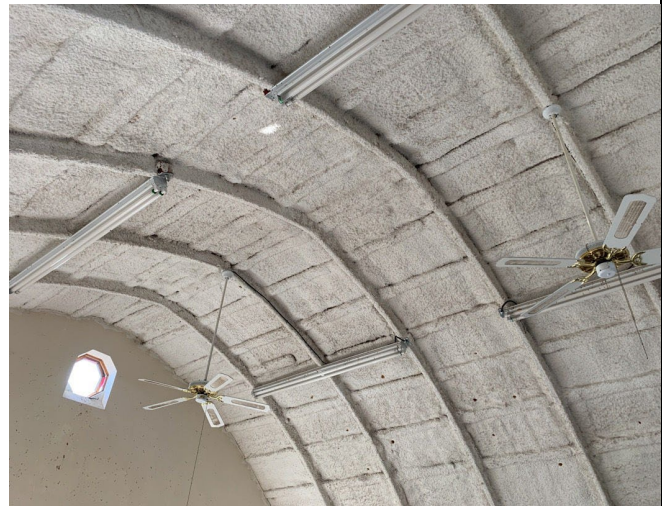
Sample Numbers: HB-08A, HB-08B, HB-08C
Material Description: Spray-on Insulation & Foam
Material Color: White
Accessible Material: Accessible
Reason Inaccessible: N/A
Asbestos Detected: Negative
Asbestos Type: No Asbestos Detected
Homogeneous Area: 2nd Floor of House
Total Approximate Quantity: 1000 SF
Condition: Good
Material Type: Surfacing
NESHAP Category: N/A
Notes: Not Applicable

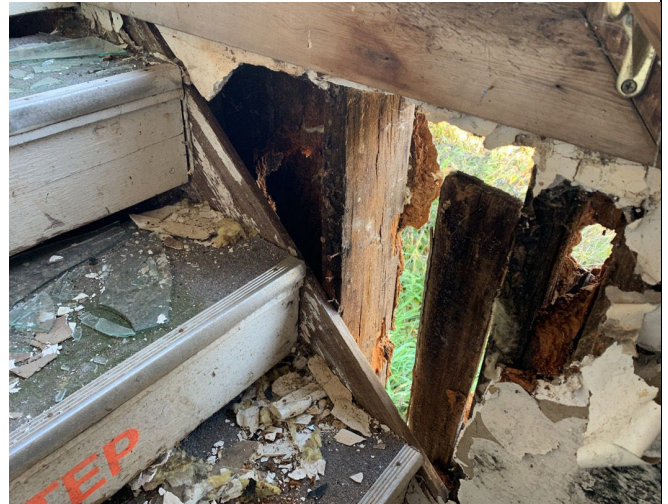
Sample Numbers: HB-09A, HB-09B, HB-9C
Material Description: Wall Underlayment
Material Color: Black
Accessible Material: Accessible
Reason Inaccessible: N/A
Asbestos Detected: Negative
Asbestos Type: No Asbestos Detected
Homogeneous Area: House Exterior Walls
Total Approximate Quantity: 420 SF
Condition: Significantly Damaged
Material Type: Misc.
NESHAP Category: N/A
Notes: Not Applicable

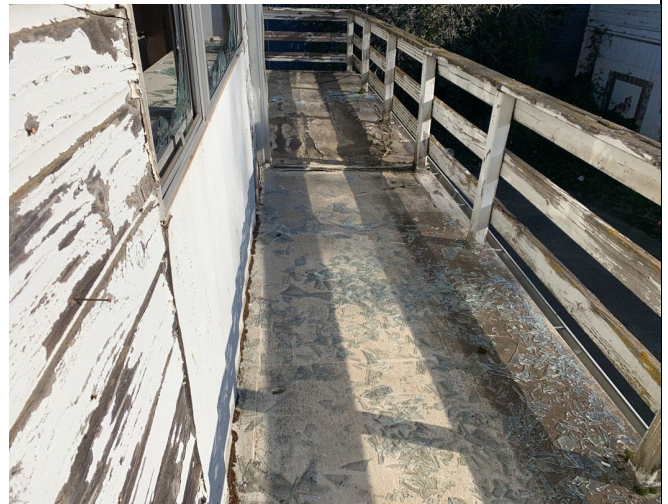
Sample Numbers: HB-10A, HB-10B, HB-10C
Material Description: Membrane Cover
Material Color: Black
Accessible Material: Accessible
Reason Inaccessible: N/A
Asbestos Detected: Negative
Asbestos Type: No Asbestos Detected
Homogeneous Area: Balconies
Total Approximate Quantity: 900 SF
Condition: Significantly Damaged
Material Type: Misc.
NESHAP Category: N/A
Notes: Not Applicable

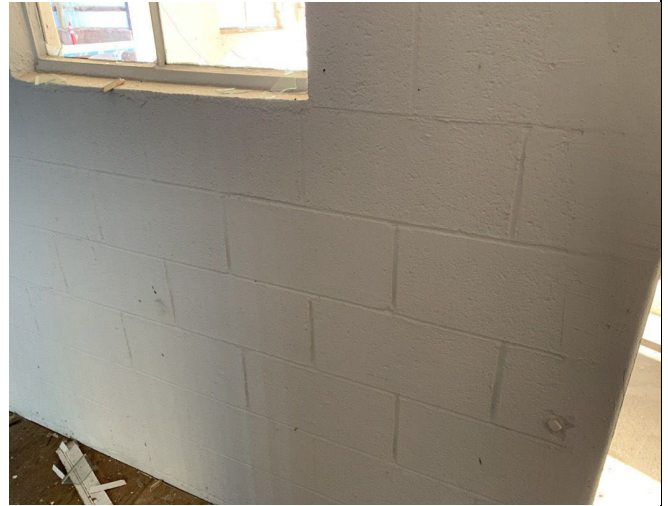
Sample Numbers: HB-11A, HB-11B, HB-11C
Material Description: CMU Grout
Material Color: Grey
Accessible Material: Accessible
Reason Inaccessible: N/A
Asbestos Detected: Negative
Asbestos Type: No Asbestos Detected
Homogeneous Area: House Interior
Total Approximate Quantity: 200 SF
Condition: Good
Material Type: Misc.
NESHAP Category: N/A
Notes: Not Applicable

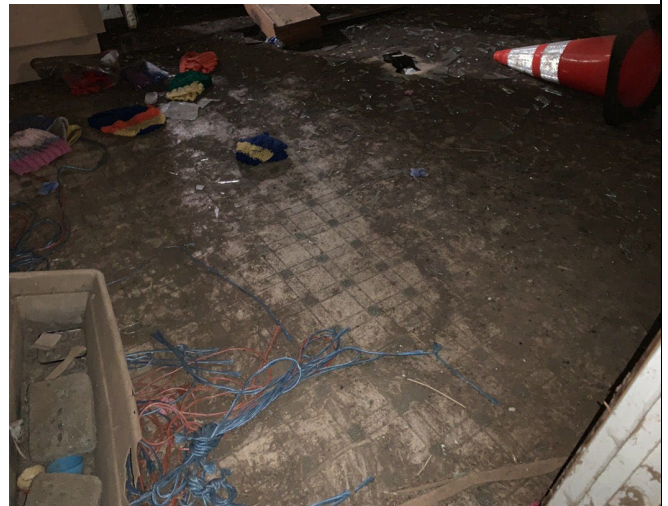
Sample Numbers: HB-12A, HB-12B, HB-12C
Material Description: Sheet Vinyl Flooring & Associated Glue
Material Color: Green White
Accessible Material: Accessible
Reason Inaccessible: N/A
Asbestos Detected: Negative
Asbestos Type: No Asbestos Detected
Homogeneous Area: Blue Barn Office
Total Approximate Quantity: 400 SF
Condition: Significantly Damaged
Material Type: Misc.
NESHAP Category: N/A
Notes: Not Applicable

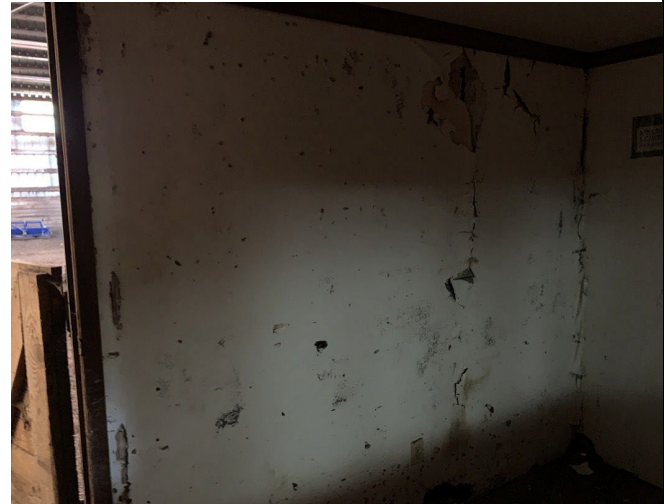
Sample Numbers: HB-13A, HB-13B, HB-13C
Material Description: Wallboard Gypsum with Joint Compound
Material Color: White
Accessible Material: Accessible
Reason Inaccessible: N/A
Asbestos Detected: Negative
Asbestos Type: No Asbestos Detected
Homogeneous Area: Blue Barn Office
Total Approximate Quantity: 500 SF
Condition: Significantly Damaged
Material Type: Misc.
NESHAP Category: N/A
Notes: Not Applicable

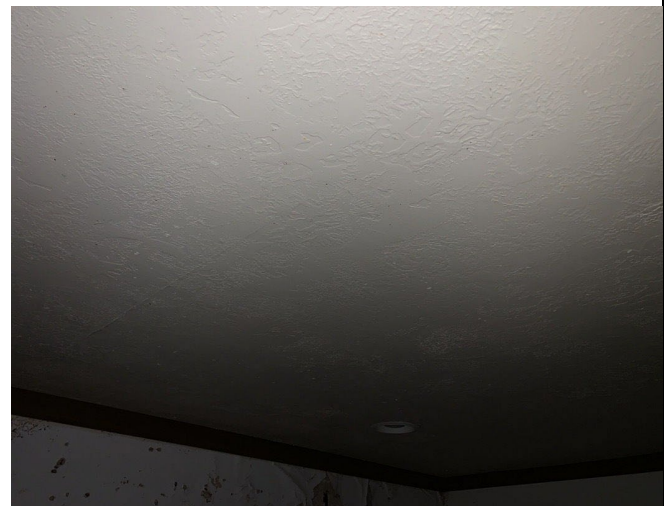
Sample Numbers: HB-14A, HB-14B, HB-14C
Material Description: Acoustic Ceiling Finish
Material Color: White
Accessible Material: Accessible
Reason Inaccessible: N/A
Asbestos Detected: Negative
Asbestos Type: No Asbestos Detected
Homogeneous Area: Blue Barn Office
Total Approximate Quantity: 400 SF
Condition: Good
Material Type: Surfacing
NESHAP Category: N/A
Notes: Not Applicable

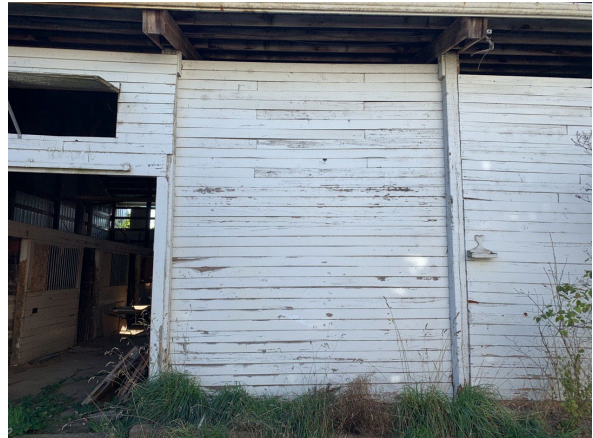
Sample Numbers: HB-L-01
Sample Location: White Barn
Description: Exterior White
Laboratory Result (%): <0.0077
Substrate: Wood
Paint Locations: Exterior Siding

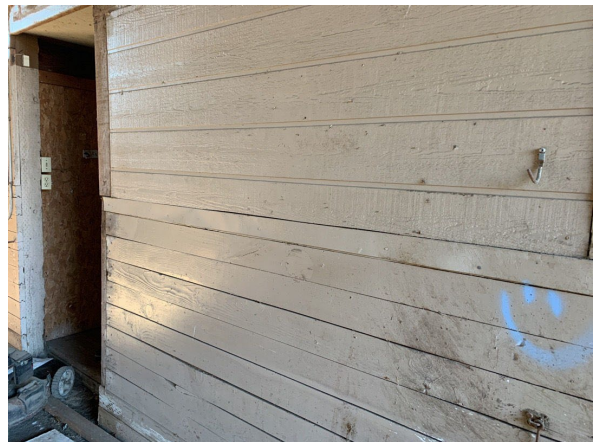
Sample Numbers: HB-L-02
Sample Location: White Barn
Description: Interior Beige
Laboratory Result (%): <0.0077
Substrate: Wood
Paint Locations: Horse Stalls

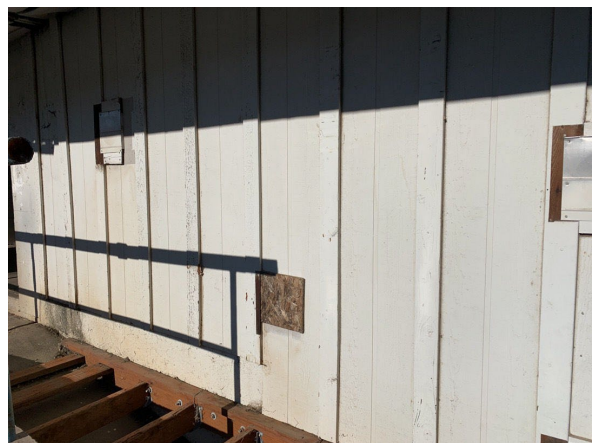
Sample Numbers: HB-L-03
Sample Location: House
Description: Exterior White
Laboratory Result (%): <0.0082
Substrate: Wood
Paint Locations: Exterior Siding
